HISTORIC STRUCTURE REPORT CCC BUILDINGS

1988

CCC BUILDINGS
BANDELIER NATIONAL MONUMENT · NEW MEXICO

UNITED STATES DEPARTMENT OF THE INTERIOR / NATIONAL PARK SERVICE /
DENVER SERVICE CENTER

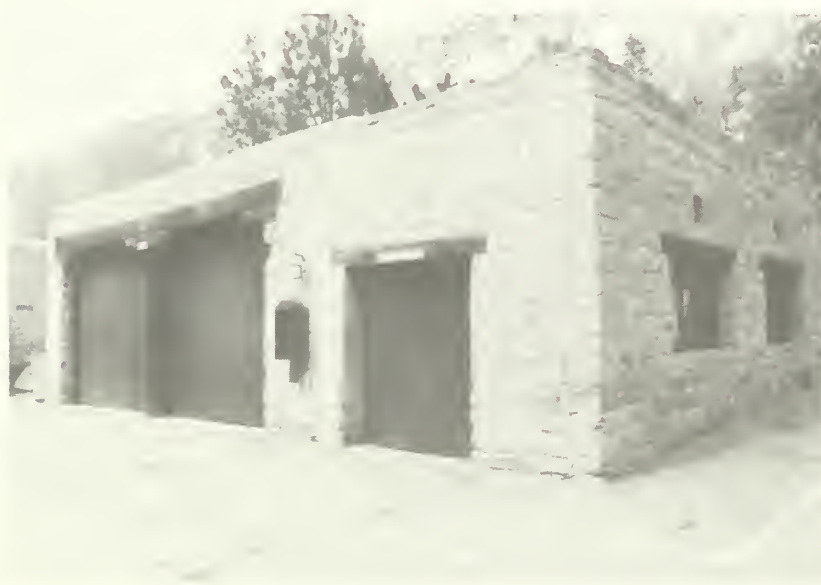
Figure 65. In 1982 the plaster had weathered off B-4 and exposed the stone. (Photo: Copeland for NPS)

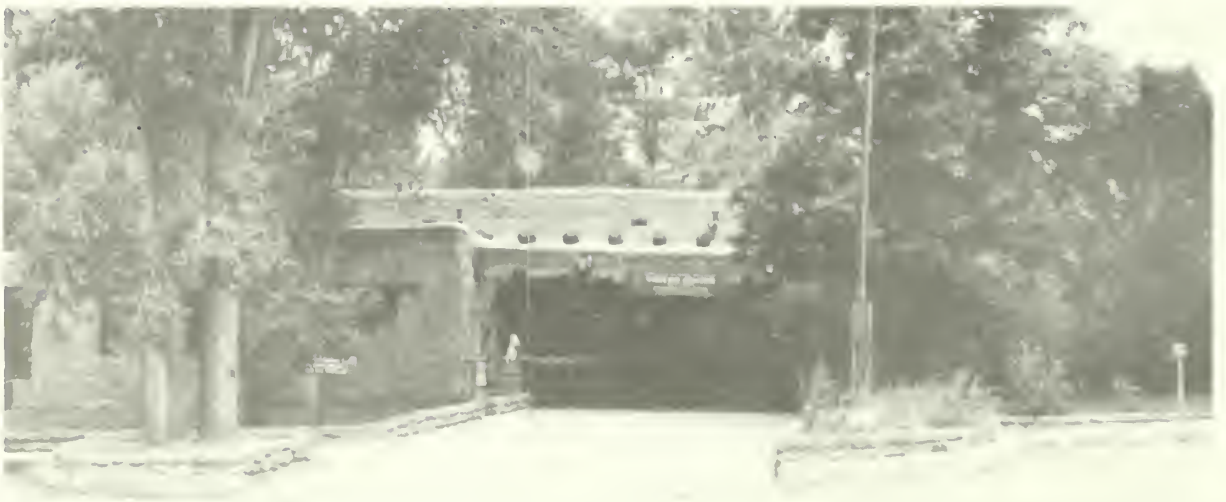
Figure 144. The front facade of the visitor center, 1988. Note the dense growth hiding much of the architecture.

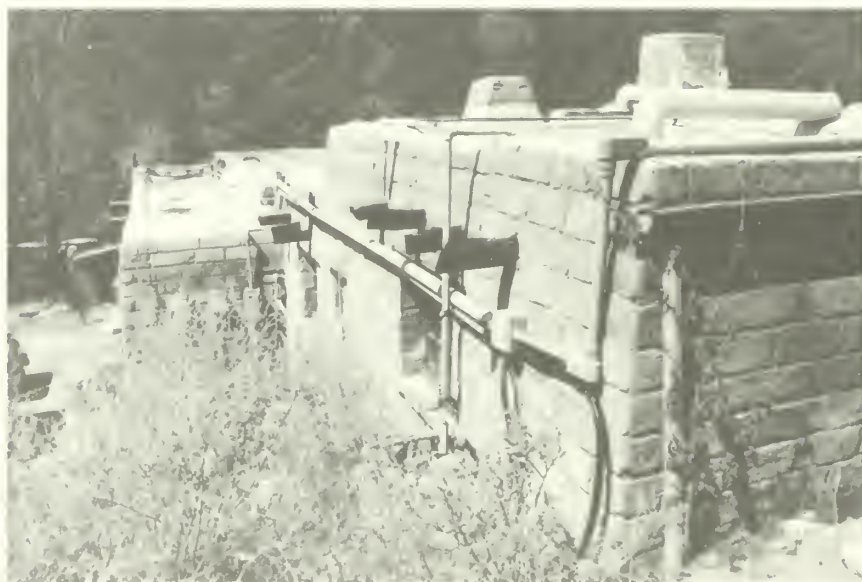
Figure 153. Rear of B-16, showing clutter of electrical and gas conduit and HVAC ductwork. (Photo: Copland for NPS)

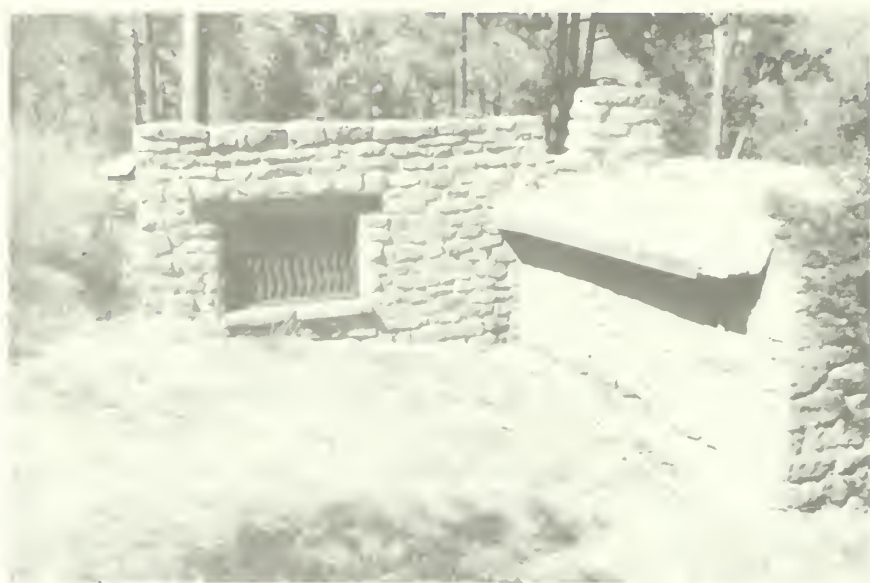
Figure 154. Rear (south) elevation of B-1, showing removed parapets and roof gutter modification. (Photo: Copeland for NPS)

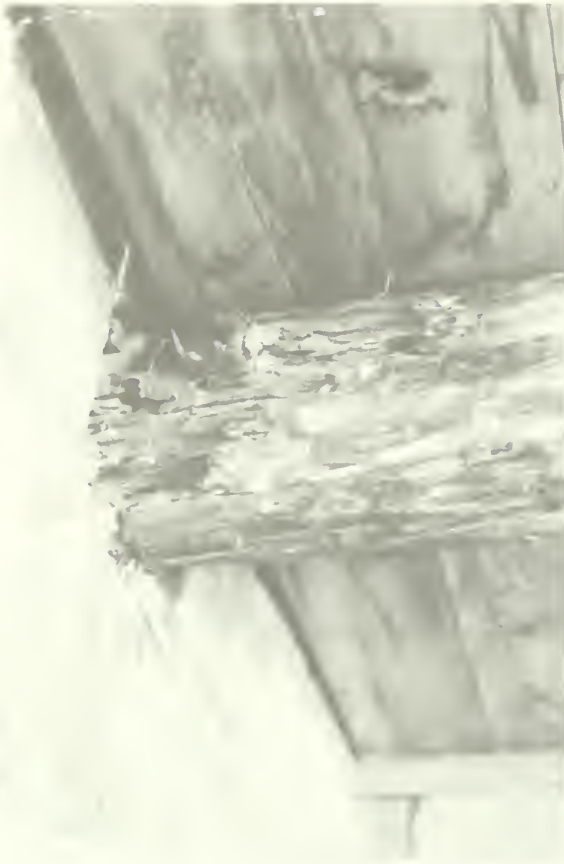
Figure 161. Viga deterioration through the wall of B-13 poses the potential for structural failure, 1984. (Photo: Copeland for NPS)

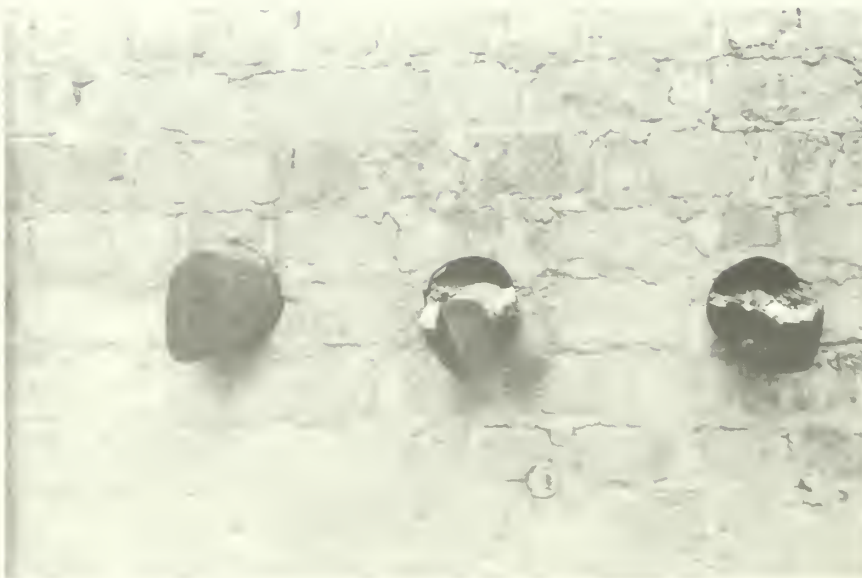
Figure 162. Severe deterioration of wood viga ends, B-7, 1984. (Photo: Copeland for NPS)

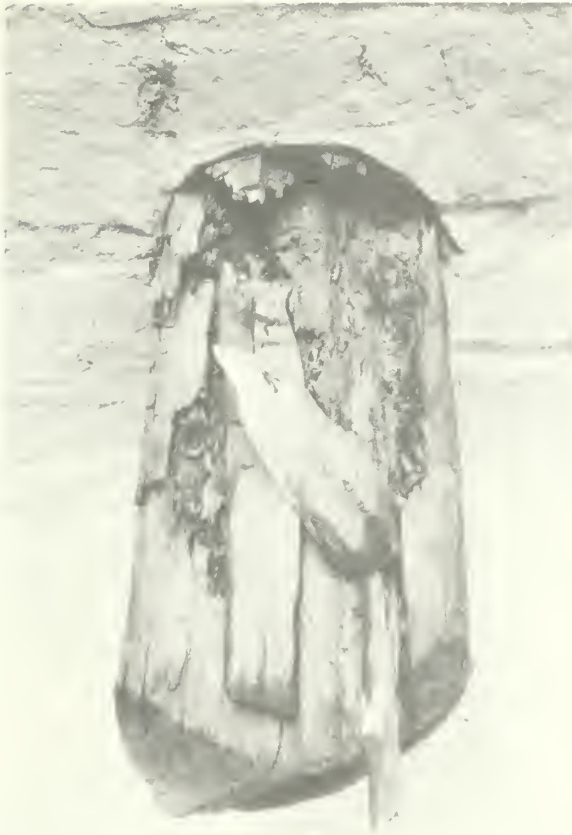
Figure 163. Severe deterioration on viga end, B-2. (Photo: Copeland for NPS)

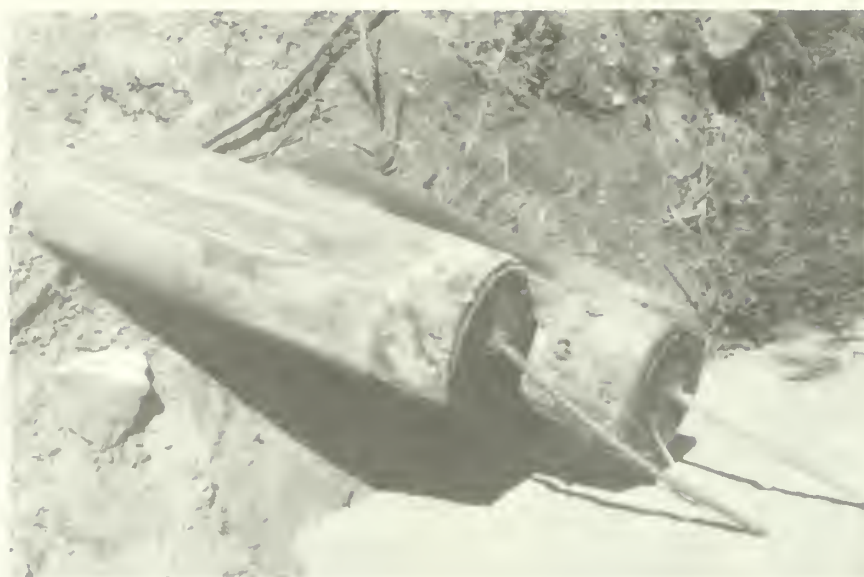
Figure 165. One method of attaching former replacement stubs using steel plate and lag screws. (Photo: Copeland for NPS)

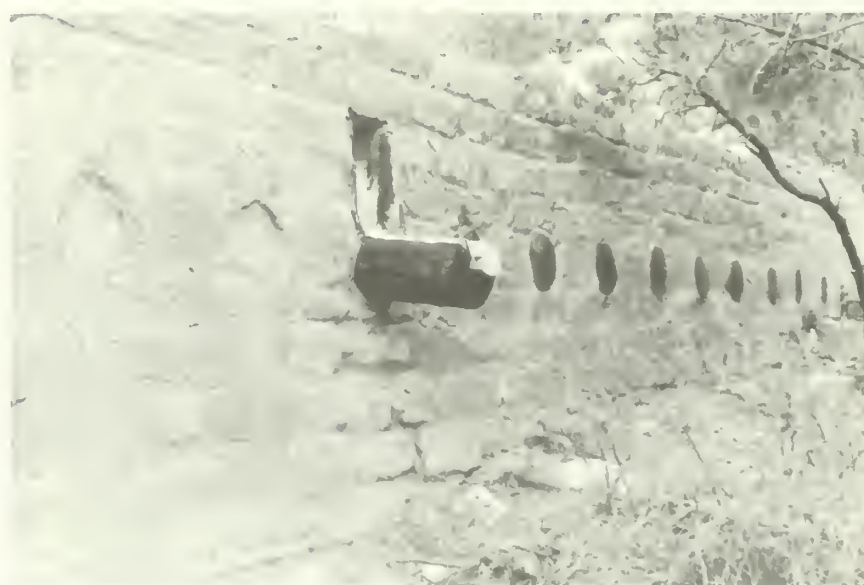
Figure 166. Two techniques of addressing deteriorated viga ends, B-6: (1) cutting off exposed end and (2) cutting back exposed end and filling in with mud mortar. (Photo: Copeland for NPS)

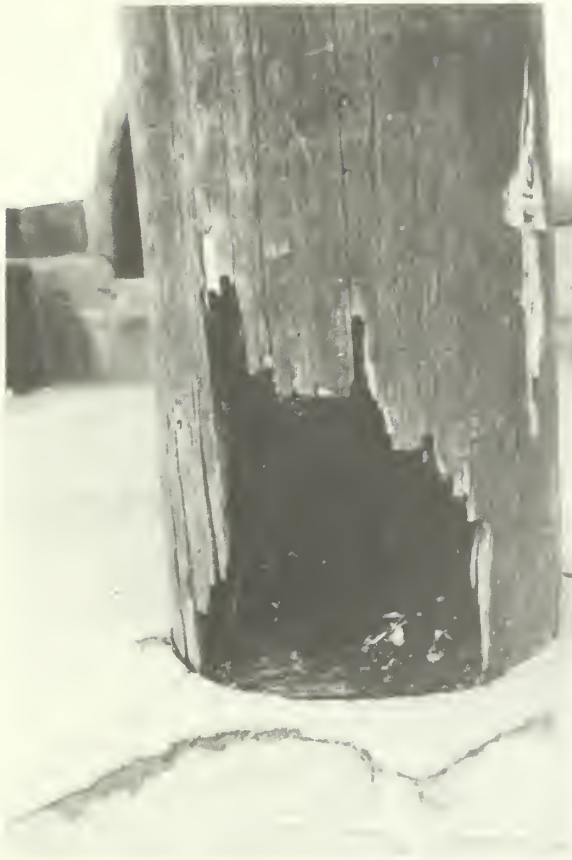
Figure 167. Column base deterioration, B-17, portal. (Photo: Copeland for NPS)

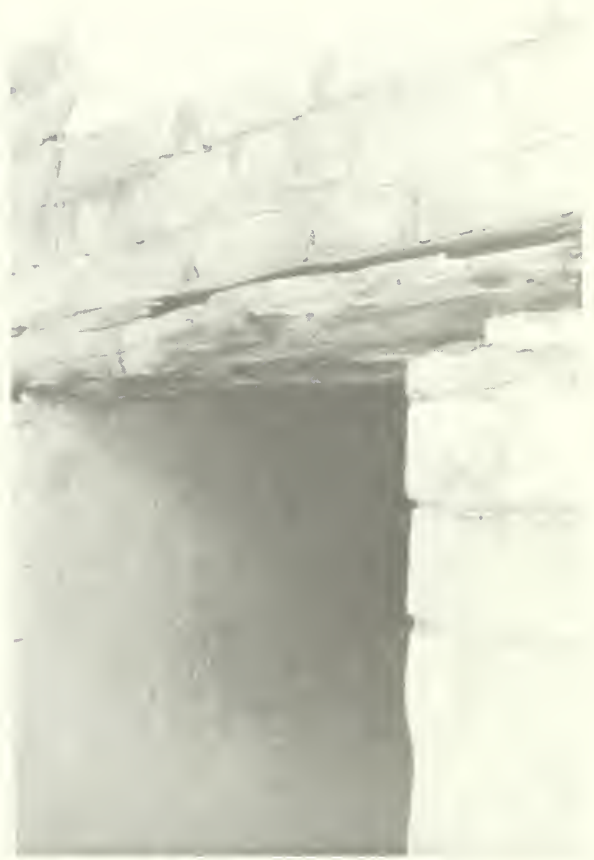
Figure 168. Deteriorated lintel, B-25. (Photo: Copeland for NPS)

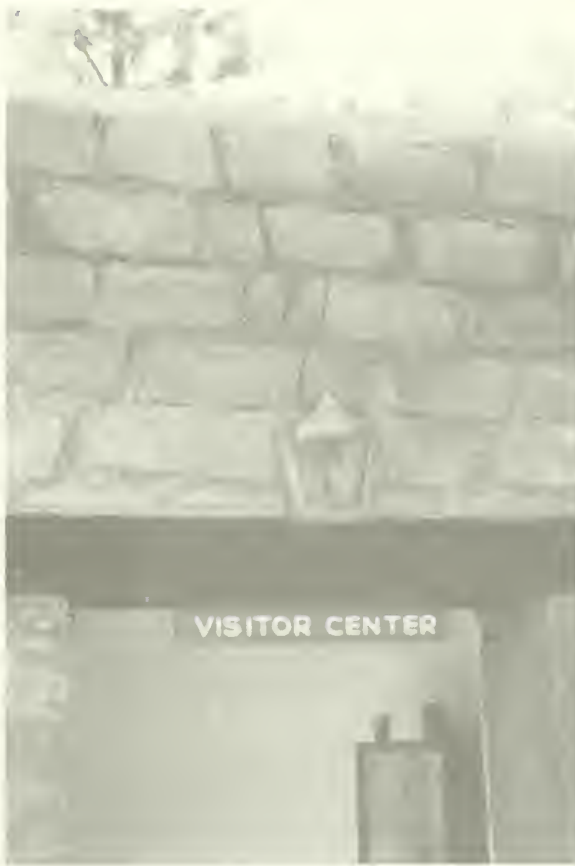
Figure 172. Wall crack in B-2 portal parapet.
(Photo: Copeland for NPS)

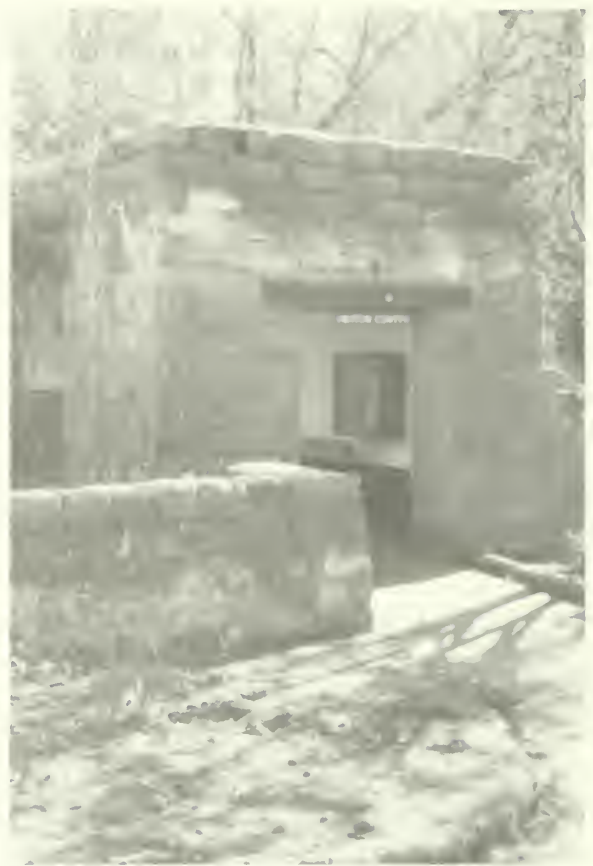
Figure 173. Surface efflorescence from falling damp on B-2 portal parapet. Note similar condition of rising damp on adjacent wall.
(Photo: Copeland for NPS)

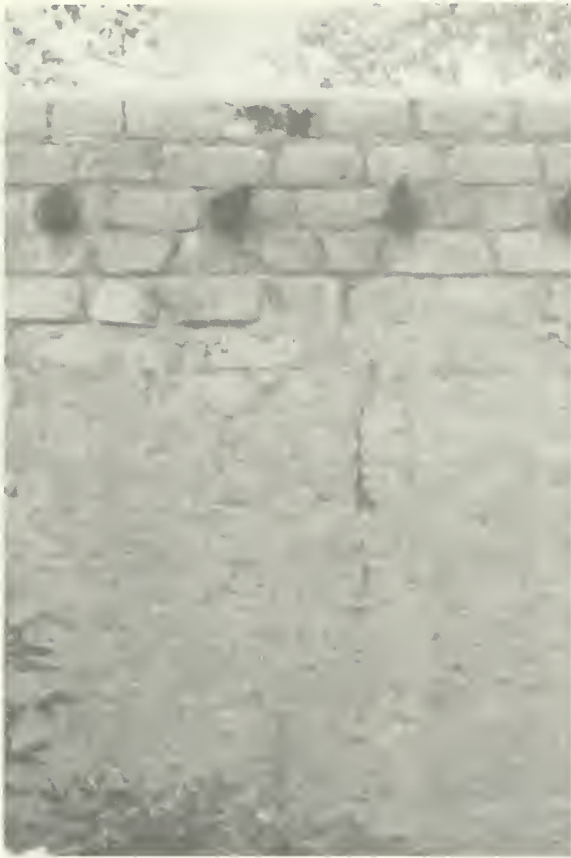
Figure 174. A wall crack on the B-2 portal parapet. (Photo: Copeland for NPS)

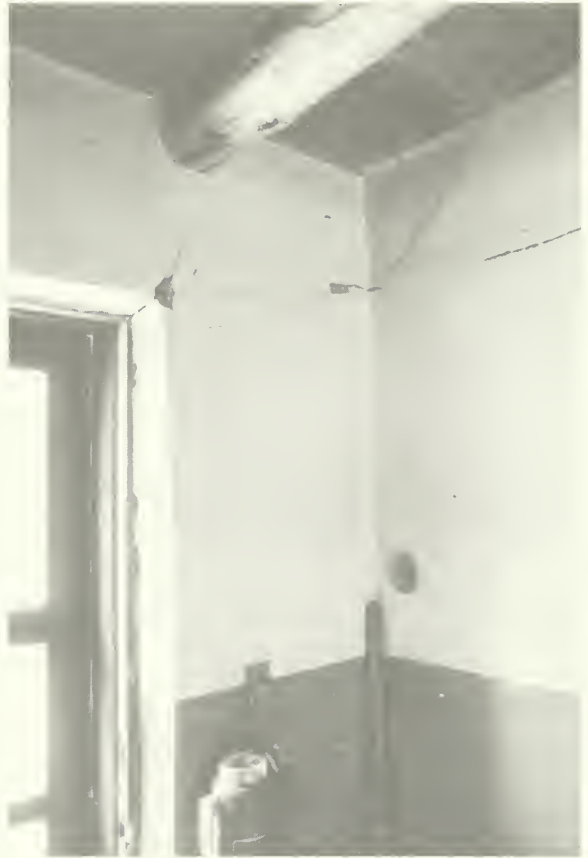
Figure 175. A plaster crack in B-27D before replastering. (Photo: Copeland for NPS)

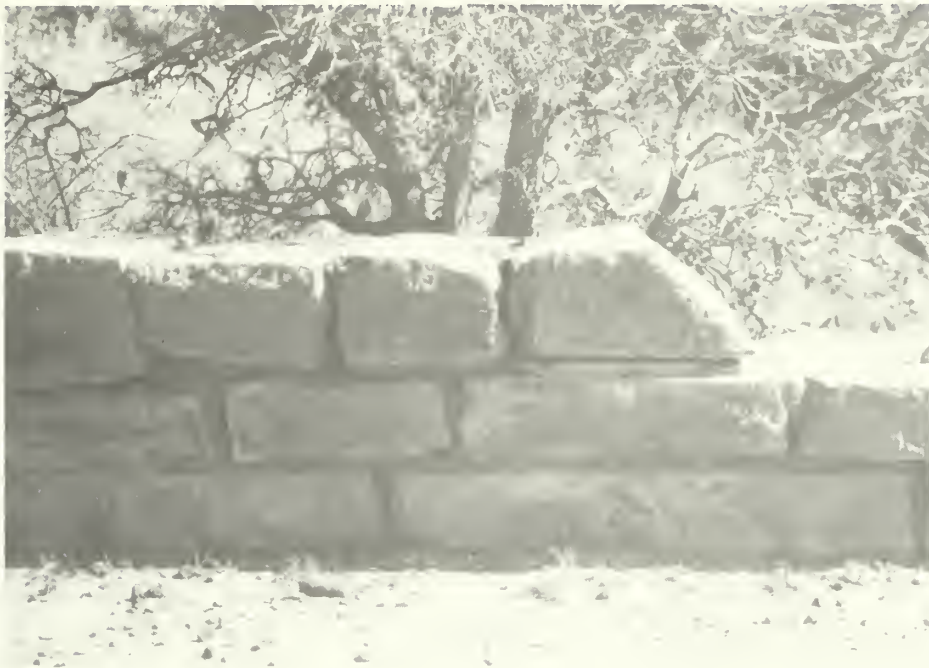
Figure 180. Detail of the entrance road wall (B-31), showing loose, separated stone. (Photo: Copeland for NPS)

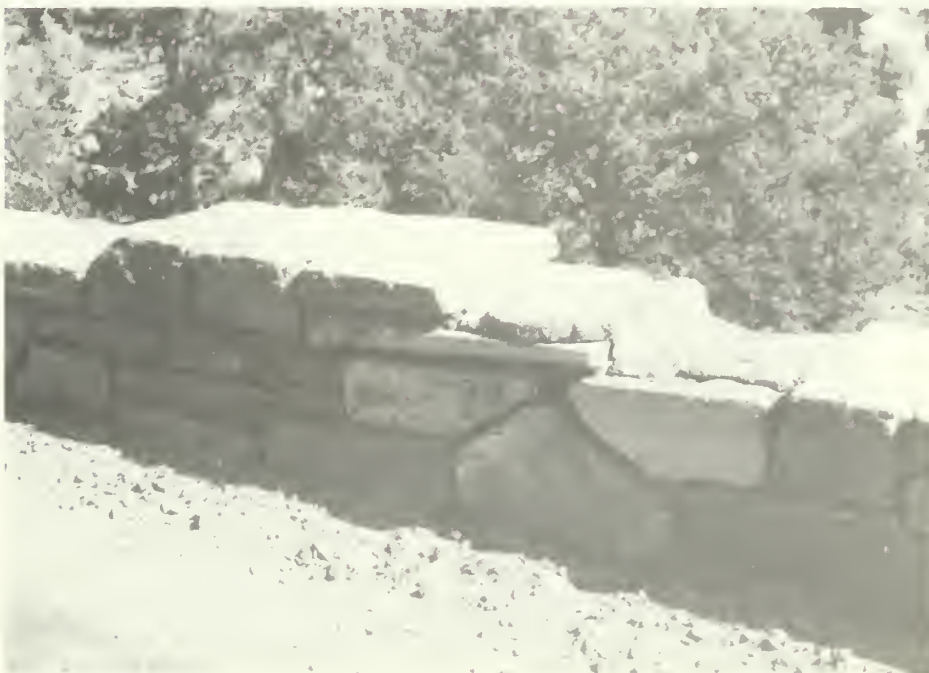
Figure 181. Detail of the entrance road wall (B-31), showing missing stones. (Photo: Copeland for NPS)

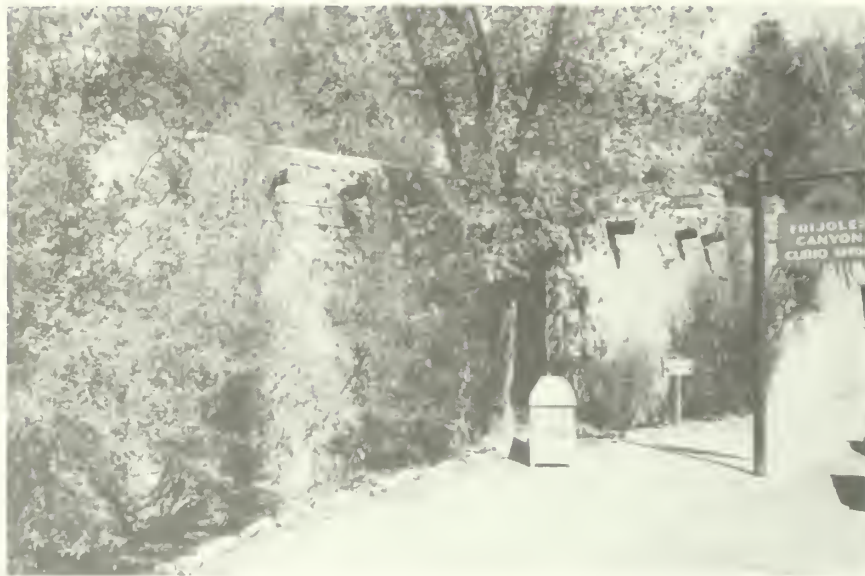
Figure 193. The wall north of the parking area, 1988. The rank growth of desert olive should be removed to expose the wall.

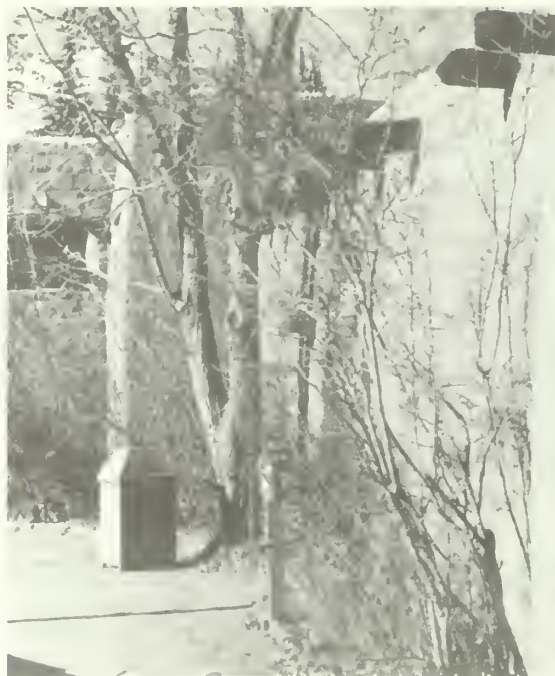
Figure 194. The parking area north wall, 1988. The box elder tree should be pruned up to raise the canopy.
